ADDENDUM NO. 01

REQUEST FOR QUALIFICATIONS (RFQ) F25-7013-39A  
BUILDING 2 RENOVATION ENGINEERING AND DESIGN SERVICES

# Building No. 2 Assessment

Phase I and Interim Phase 2 | December 2019

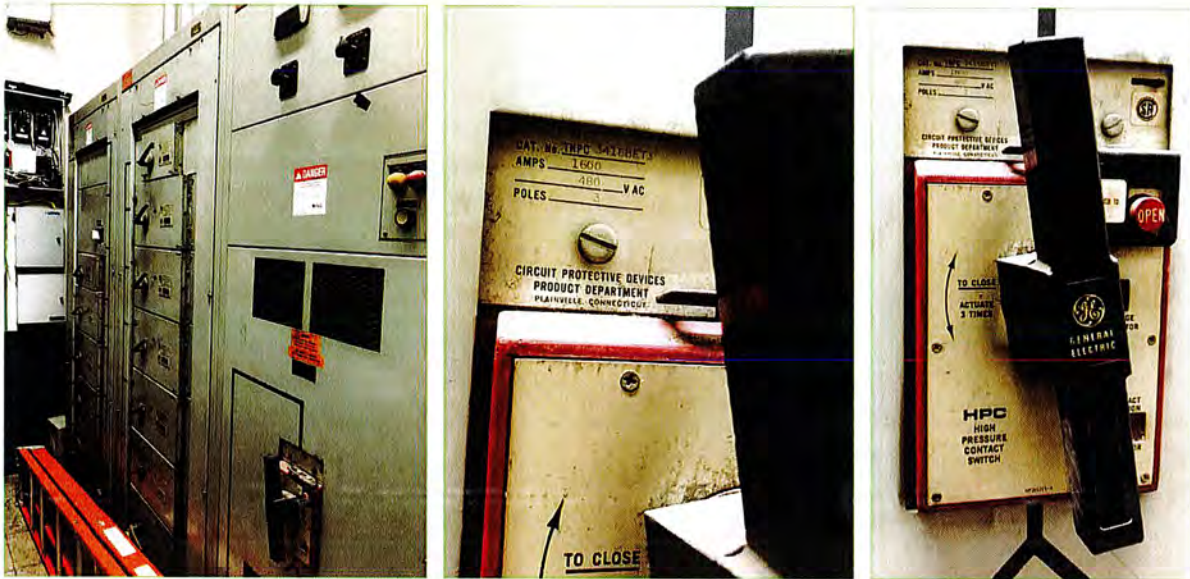
The *Arc Flash Report* one-lines indicate that Building 2 has 1200A fuses at the SW2. Field observation shows a 1600 amp, 480V, 3 Phase main switch for SW2. The main switchboard consists of a main section and two 800amp distribution sections with 1600 amp rated neutral amps. The switchboard appears to have Arc Flash Labels dated 11/07/2017, which correlate to the *Arc Flash Power Report*. The switchboard feeds the eight rooftop units and the following panels. Generally, the main switchboard is in good condition; however, there is only one possible space for a future breaker.

Main Switchboard SW2 1600 amp Rated, 1200 amp Fused

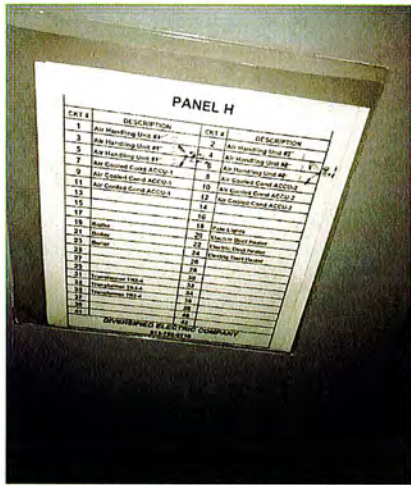
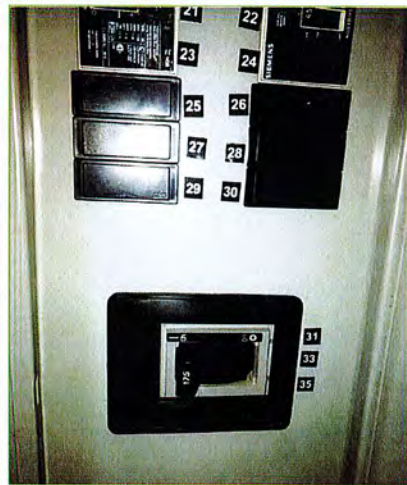
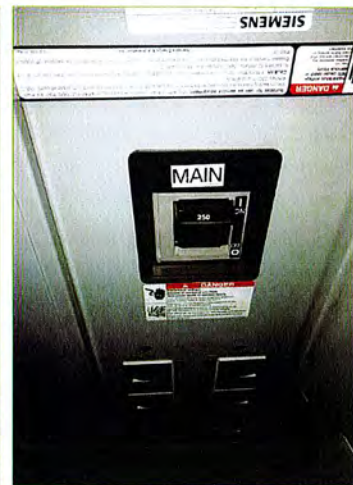
Panel H (fed from a 250 amp breaker) is located in the mezzanine. Panel has a 250 amp main breaker and sub-feeds panel N (208V) with 350 amp main breaker through a transformer.

Panel H (480V) with 250 Amp MCB

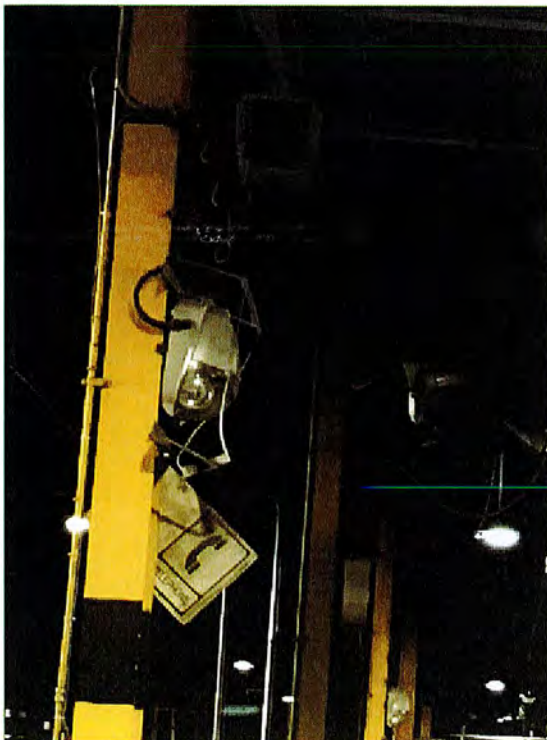
Egress lighting is achieved with emergency battery operated egress lights. There are a couple of lights that need to be tested to ensure that they are functional and, if so, remounted or replaced. Some of the wire guards appear to be damaged and should be replaced.

Wire Guard (appears damaged)

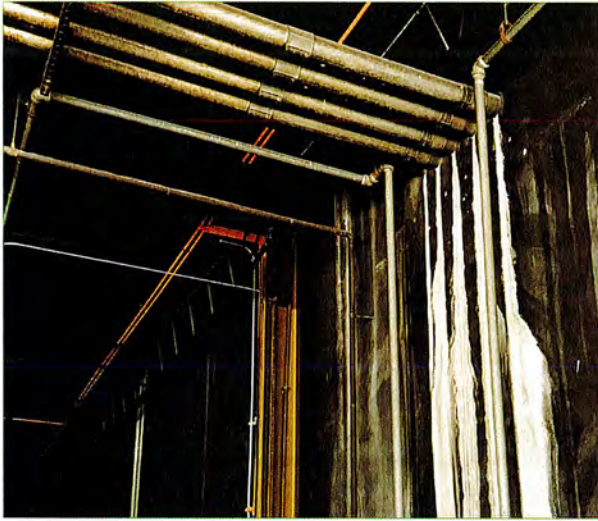
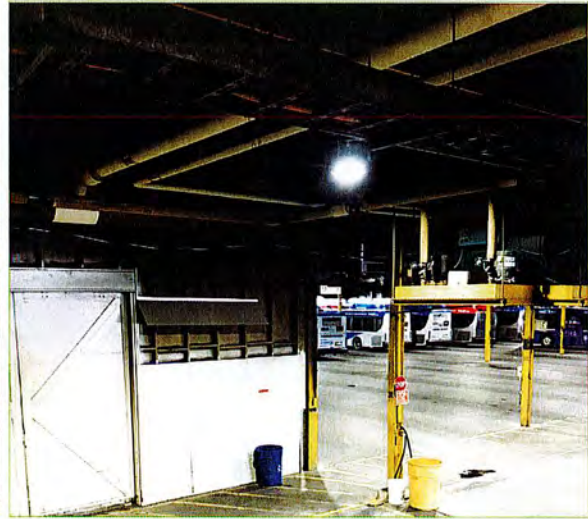
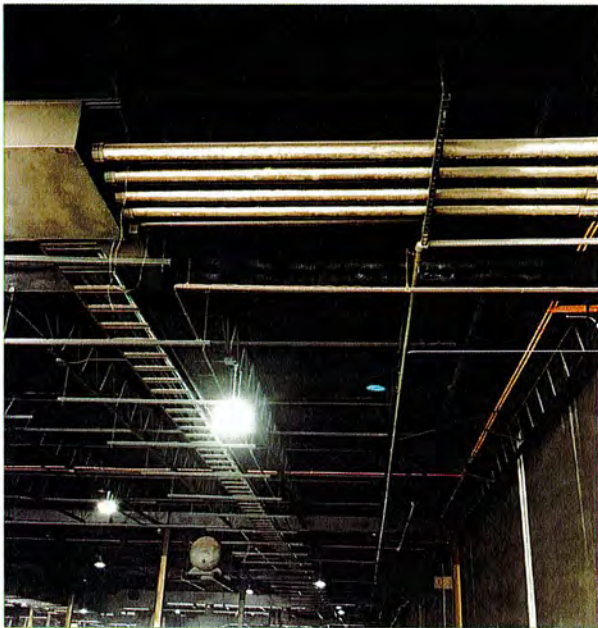
Telecom System

There is a main cable tray traveling the length of the Building 2 that appears to have data cabling that feeds wireless access points throughout the building. The conduit entering the building appears to be in good condition although the penetrations into the building do not appear to be sealed and there is evidence of water entering.

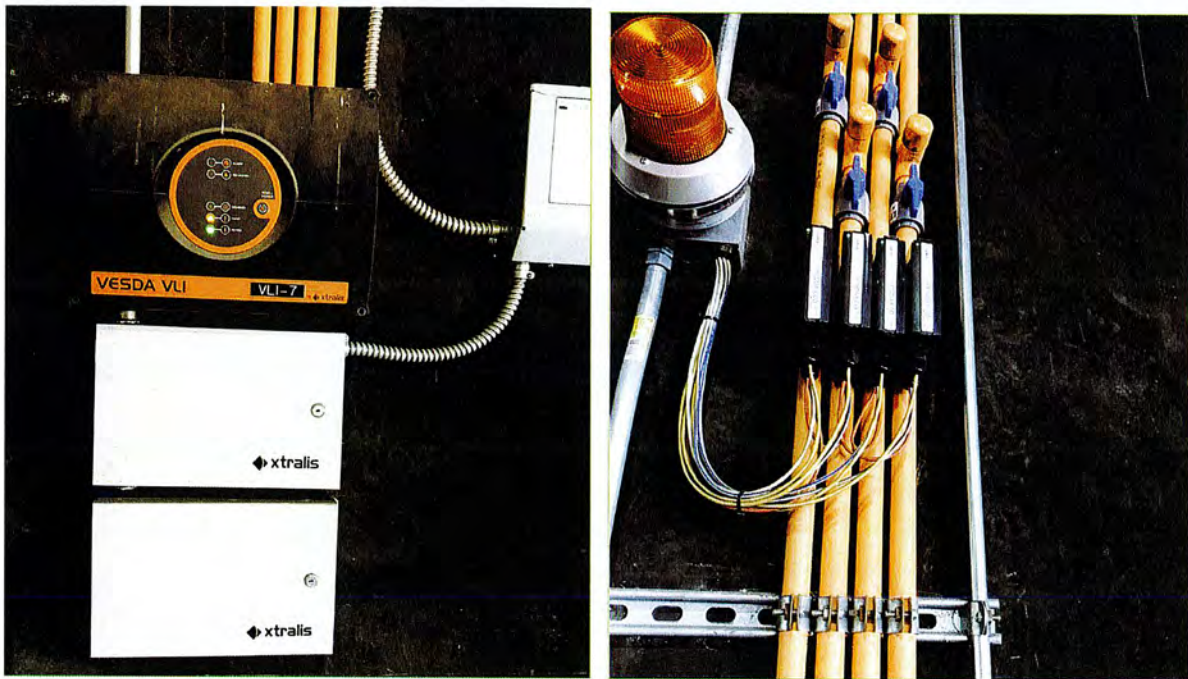
Several of the units (#7, #6, and #4) were observed with a fault indicator light on. The balance of the units appeared to be in good condition with no faults. Unit #8 was exposed to bird waste and debris and should be cleaned. It was noted from conversations with staff that the detectors had recently been replaced and all units were functional. Some of the units and piping had diesel gas residue buildup. It is recommended to clean all of the units and pipes to remove the diesel build up.

For maintenance, the VESDA VLI smoke detectors have a life expectancy of approximately ten years. The faults on the system could be caused by air flow issues due to dirty pipes. Maintenance should review data from each detector to determine and address any faults. Pipes can be blown out and/or vacuumed to remove airflow obstructions.

VESDA VLU Unit #7 (detector, battery backup, and flow sensors)

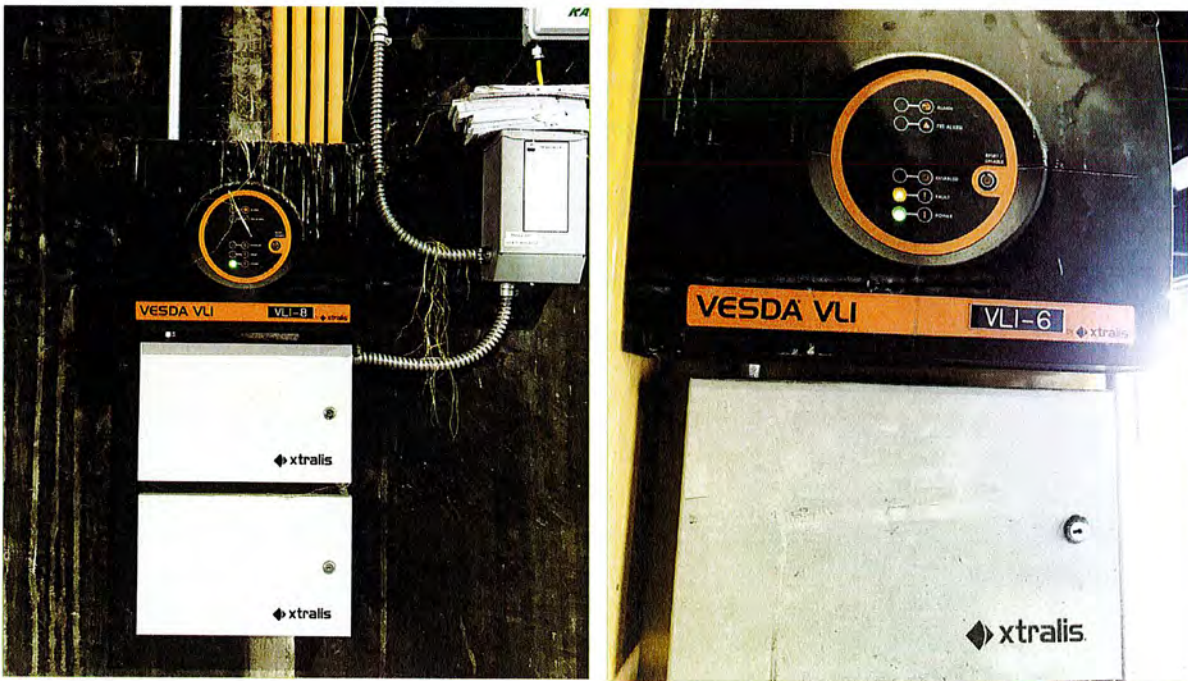
Units #8 and #6 with faults, debris, and diesel fuel buildup

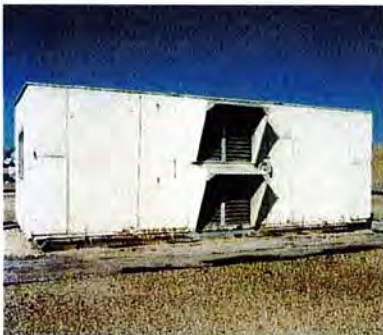
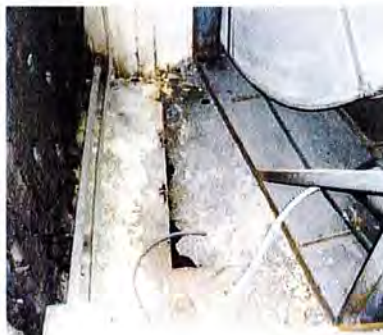
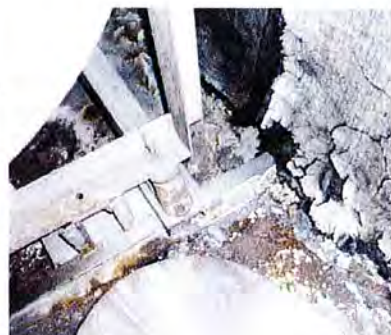
Rooftop Units

- The existing rooftop units are original to the building (installed in 1974) and are past their useful life.
- The unit housing is rusting and the insulation is falling apart and the roof curb is rusted as well. The housing cannot handle any new fittings, welding, or bolts. The poor condition of the housing is the main cause for the units leaking conditioned air to the atmosphere, which is wasting energy. The rooftop unit support structure is weakened and requires major repair and reinforcement along with roof repair.

- The recovery wheel is not in working condition and is deactivated from the unit, which means the conditioned air is exhausted and no energy is captured back for reuse. This defeats the energy saving purpose of the unit.

- The rooftop unit return air opening is very wide providing potential for the bus exhaust to run directly into the return air opening. This creates a risk for explosion or fire at the unit even though the building has a CNG detection system.

Since the rooftop units are past their useful life, they can fail at any time. Repairing a unit is difficult and costly. Due to the age and condition of the existing units, it is not recommended to perform major repairs due to financial reasons. It is acceptable to use the units until they fail, understanding the following risks and implications if a failure occurs:

- Preventative Maintenance (perform as soon as possible):
  - Inspect the units and replace broken parts such as fan belts, motor and fan blower bearings, and lubricate.

- Change filters.
  - Clean all ducts and diffusers to remove oil residue which may cause a fire with CNG buses.
- Replacement parts as they fail:
  - Estimated cost breakdown for each part is outlined below.

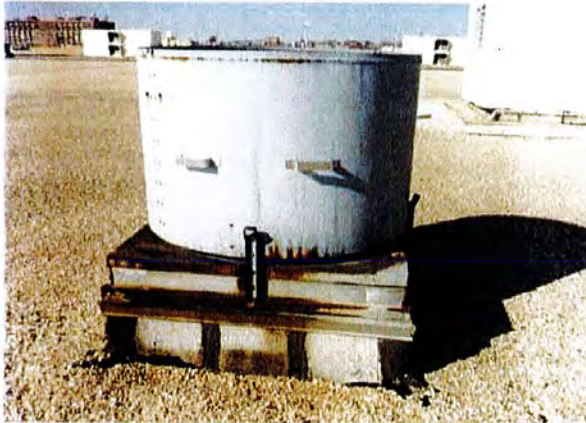
Exhaust Fan

There are sixteen (16) rooftop up blast exhaust fans each with an estimated 7500 cfm exhaust. The fans are controlled by the CNG detection system and CO2 sensors. The existing CO sensors are covered are not properly covered. A manufacturer's recommended dirt cover needs to be provided.

- The existing exhaust fans are old and still working. There is no energy saving since the unit does not have a Variable Frequency Drive.

Since the exhaust fans are in working condition, it is recommended to allow them to run for the next five years until they fail. Unit replacement costs are outlined below.

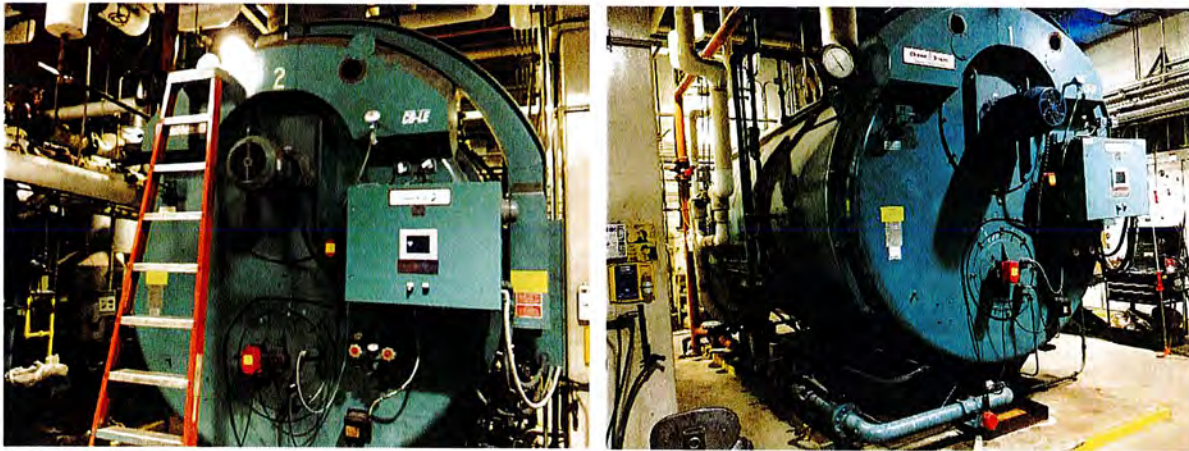
Boilers

- The existing boilers were installed in 2008 and are in good working condition. These boilers need daily attention for maintenance or service. This is one of the drawbacks of the boiler steam system compared to gas fired rooftop units normally requiring less maintenance.

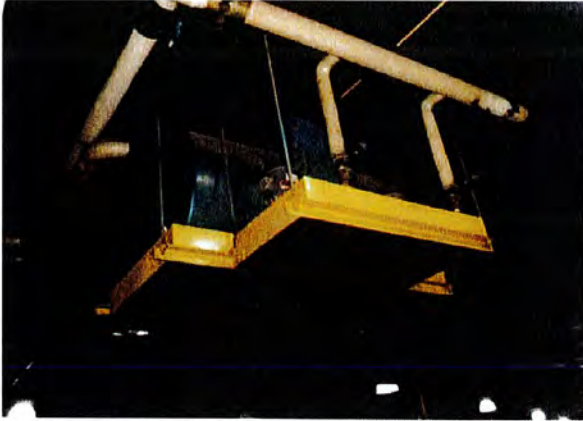
Condensate Pump

There are two condensate pumps at two locations in the bus storage room. The pumps were installed in 1974, which is original to the building. The pumps need to be replaced. Steam pipes and traps are also original to the building. The pipes are in working condition although leaks have been observed near the condensate pumps. The pipes need to be inspected for leakage and heat loss.

The steam pipes are original to the units. There are some leaks near the condensate pumps. The steam pipes must be sealed air tight to avoid leakage. Condensate pumps can be replaced as they fail for the next five years.

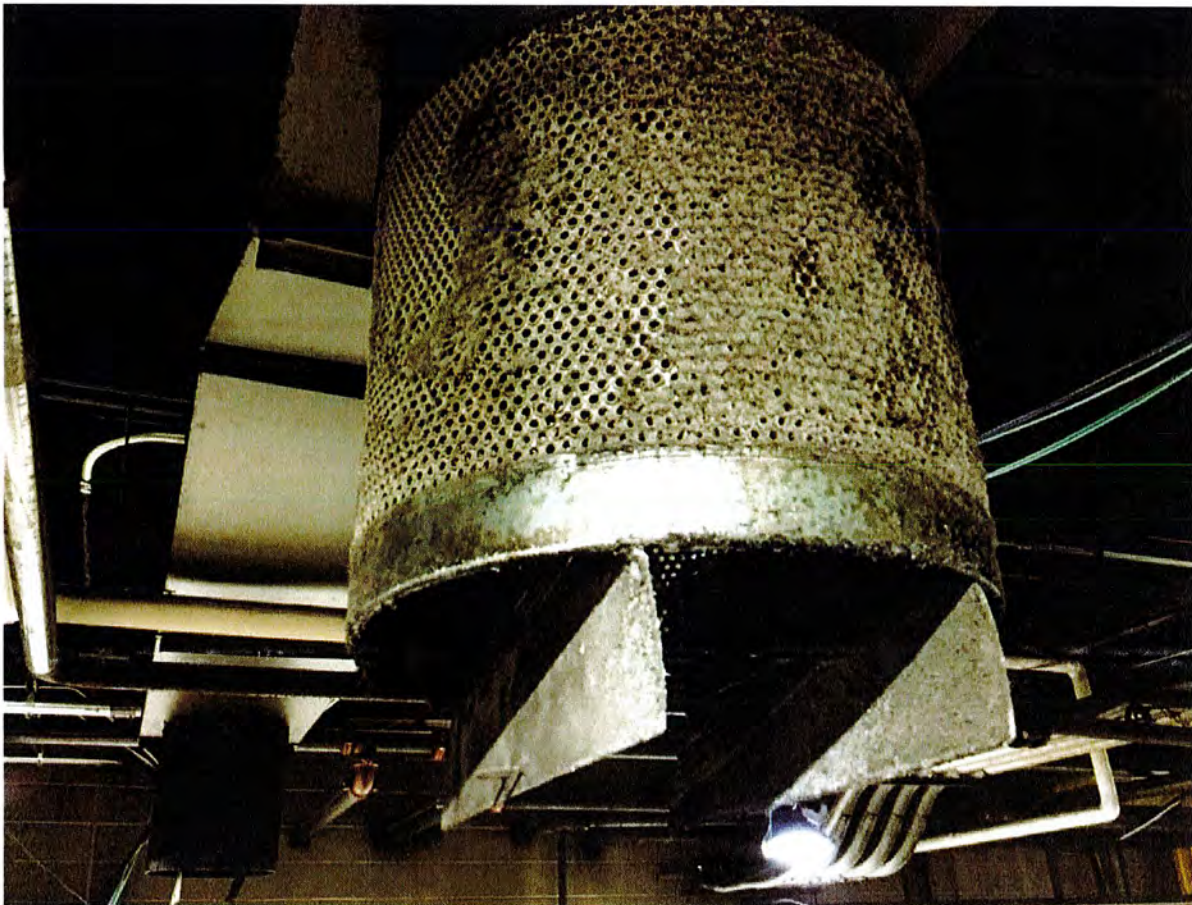
Ductwork

- The supply ducts and diffusers need to be replaced to match new demand and layout. The return opening is at the bottom of the unit and is protected with a wide bar grille. Some of the grilles are covered with bird waste.

Ducts and diffusers shall be cleaned for better efficiency, deliver clean air, and prevent a cause of fire.

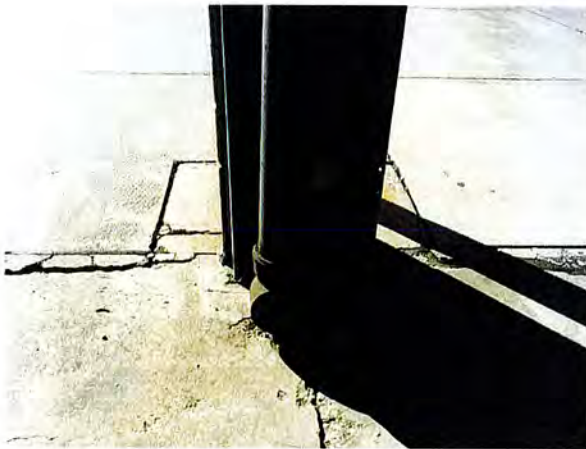
Storm Drain

The roof slopes to the east and west walls and has roof drains for primary drainage and scuppers that provide secondary drainage. The drain pipe is along the interior of the precast wall and connects to the downspout boot at the slab level. It has been noted there is PVC down pipe and broken fittings near the down spout boot at four locations.

- Some of the storm drain risers are broken near the finished floor. All drains need to be repaired and cleaned on a major maintenance schedule.

The plumbing system maintenance should include cleaning the parking floor drain and piping, replace five storm drain down pipes, and connect to the existing down spout boot.
