ADDENDUM NO. 01

REQUEST FOR QUALIFICATIONS (RFQ) F25-7013-39A  
BUILDING 2 RENOVATION ENGINEERING AND DESIGN SERVICES

# Building No. 2 Assessment

Phase I and Interim Phase 2 | December 2019

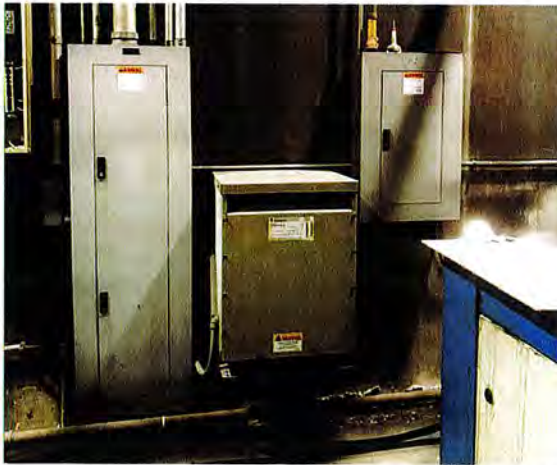
Panel PP1 (480V), 15Kva Transformer and Panel CP-1 (208V)

The switchboard has one available space based on observation of the exterior which would need to be confirmed that there is an actual bus behind the cover.

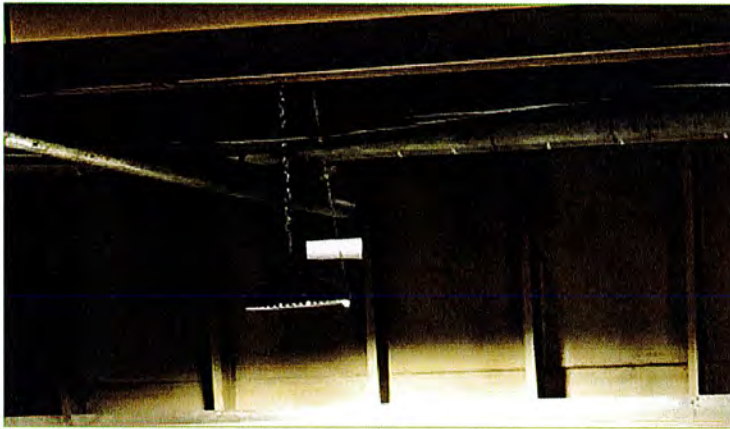
The lighting in the bus storage bays has been upgraded to LED. The fixtures appear to be chain hung and have a safety chain attached. They hang down from the structure.

View from the Mezzanine (existing LED pendant)
